NTSB National Transportation Safety Board

Canadair Challenger

November 28, 2004

Montrose, Colorado

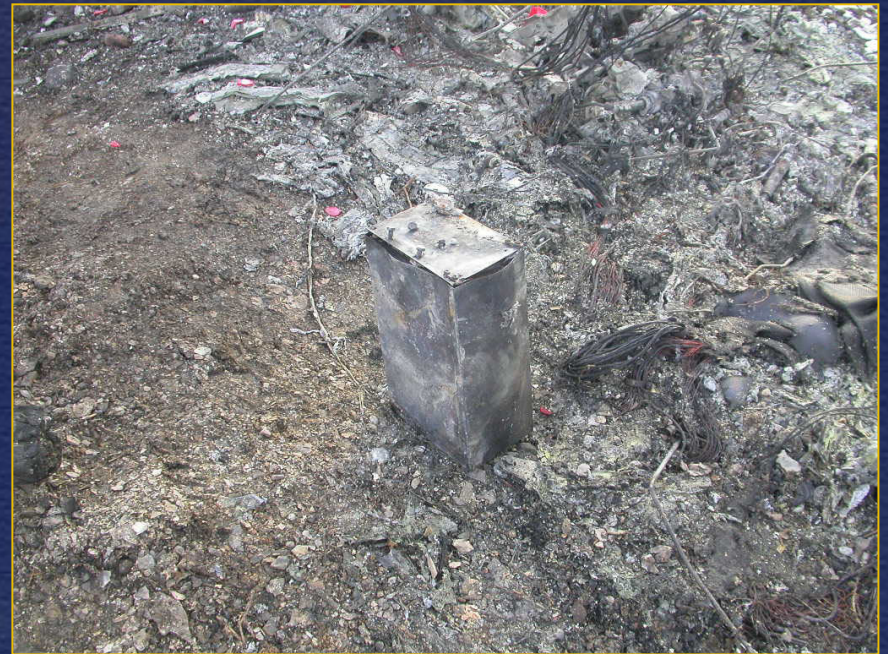
Cockpit Voice Recorder

- Airplane equipped with CVR but no FDR
- CVR tape captured about 32 minutes of events up to crash
